## Annex A: Headlines from the Phase 1 Report

## Circumstances associated with the flooding of Llanbedr in January 2014

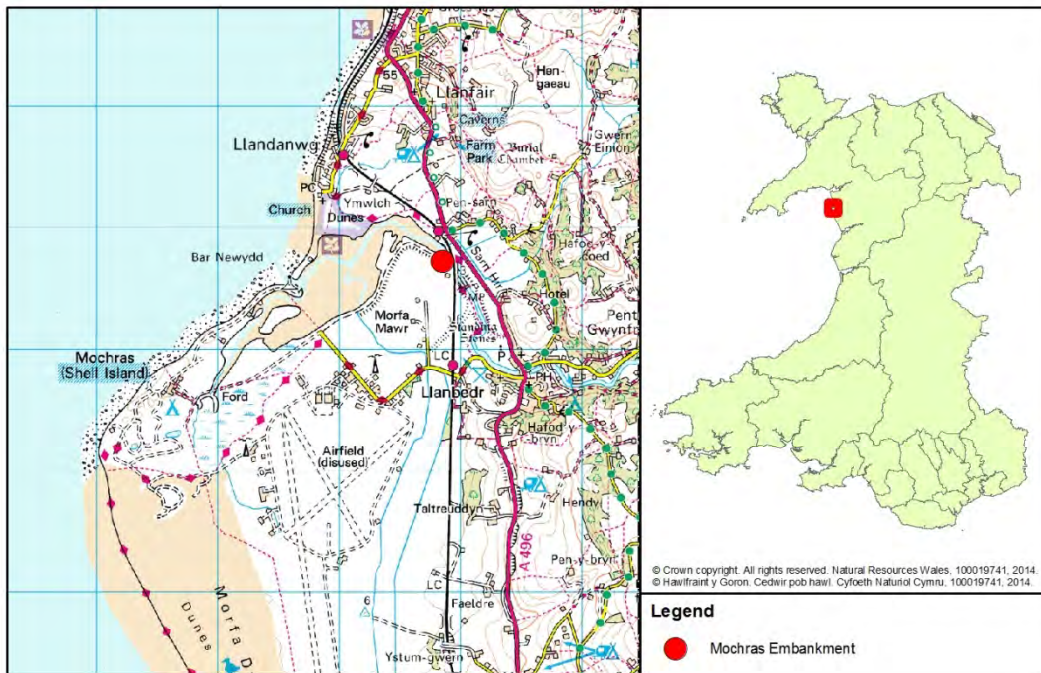
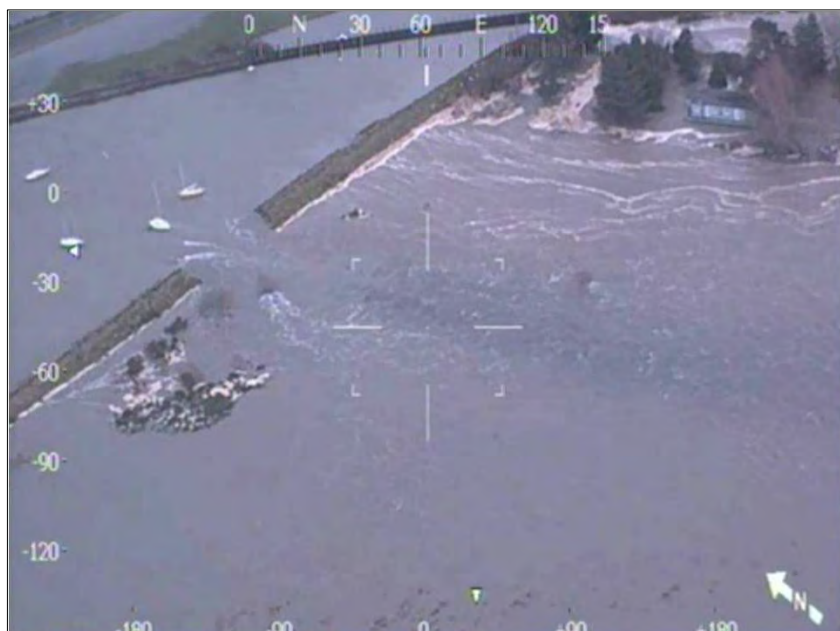
In January 2014 the Mochras flood bank at Llanbedr in north west Wales was breached over a length of approximately 50m, as a consequence four properties were flooded, along with significant areas of agricultural land twice daily under high tide conditions.

This section of embankment has been in place for many years. It is believed it was originally constructed using locally sourced material (i.e. river gravel silts and clays etc.) with the design height defined from previous flood event levels. The flood bank as a whole is a grass earth embankment with reasonably wide crest widths and, although slender in places the front and back slopes are acceptable.

The majority of the seaward face is reinforced by a stone berm and stone '*rip rap*' that extends two thirds up the height of the embankment. The purpose of this is to reduce wave impact and bank erosion. The stone rip rap does not extend along the whole length of the embankment and the more sheltered section does not include this stone rip rap

In early April work to repair the breach was completed. This was a challenging project due to the difficult access conditions and the hostile tidal environment. The works required around 12 weeks to complete and involved construction of an access road to the breach and 15,000 tonnes of boulders, clay and soil.

The new section of the bank has been reinforced with a solid clay core, strengthened with boulders and covered with topsoil to bring it back to the required level of flood protection.

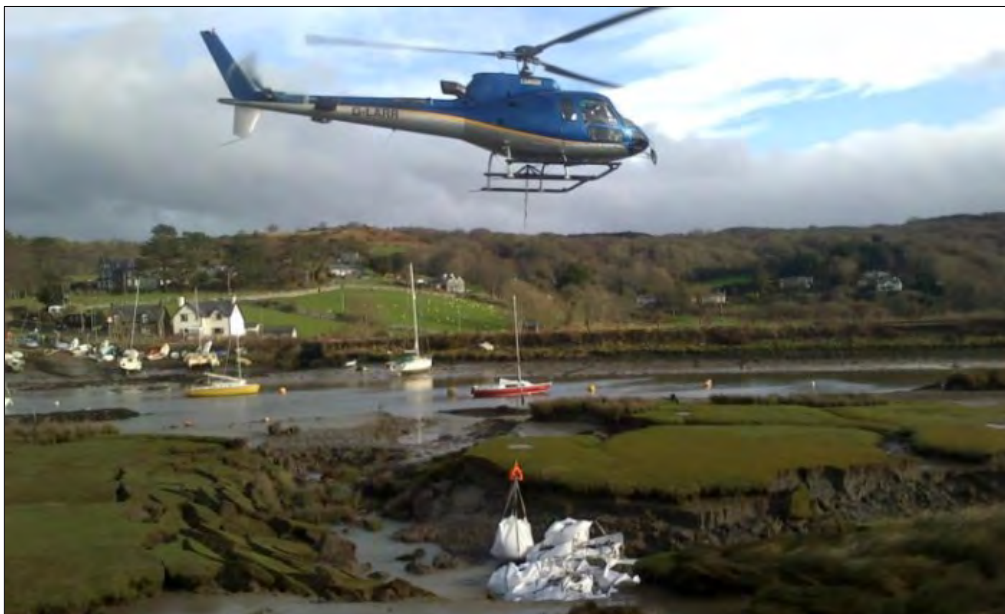
In the immediate aftermath of the storm, a helicopter was used to position giant, industrial-sized sandbags to fill the gap ahead of further predicted high tides.
